A review: The analysis of fires in Chinese historic building and research progress on the fire protection

Chinese historic building fire
Wooden structure
Fire damage evaluation
Fire protection
Fire case study

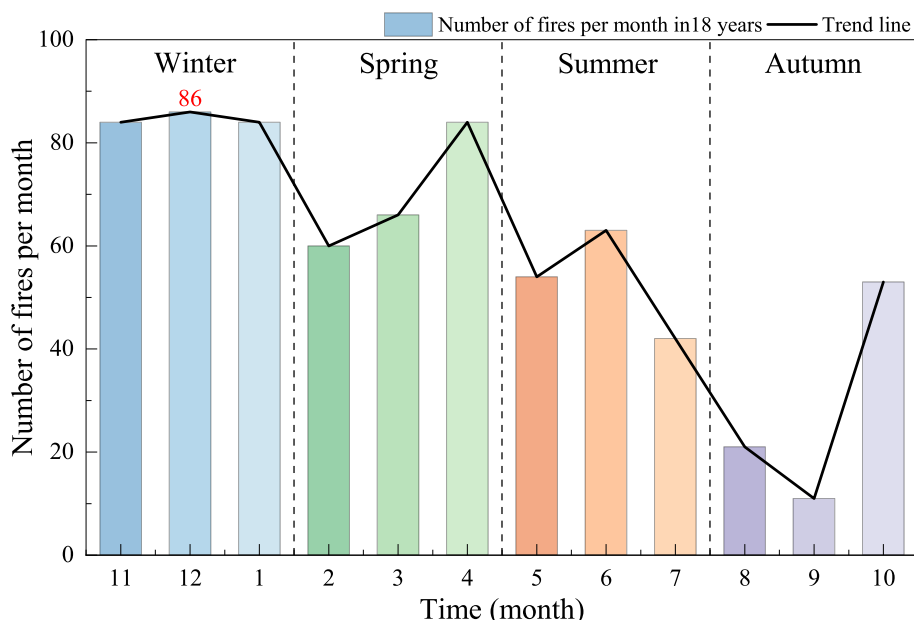
Fig. 1. Number of fires in historic buildings across the months between 2000 and 2017.

The relation between the number of fires and the months where they occurred is shown in Fig. 1. When analysing these data, it is found that fires in historic buildings occur more frequently in January, April, November, and December, i.e. fires mainly occur predominantly in winter and in spring. From these results, it is inferred that this distribution of fires across the months can be related to Chinese religious activities and traditional festivals such as the Qingming Festival in spring or the Spring Festival (i.e. the Chinese New Year) in winter. During these celebrations, incense and fireworks are abundantly used in historic buildings, which leads to the occurrence of a significant number of fires. Furthermore, the drier weather conditions usually found in spring and winter also facilitates fire ignition to occur in wooden historic

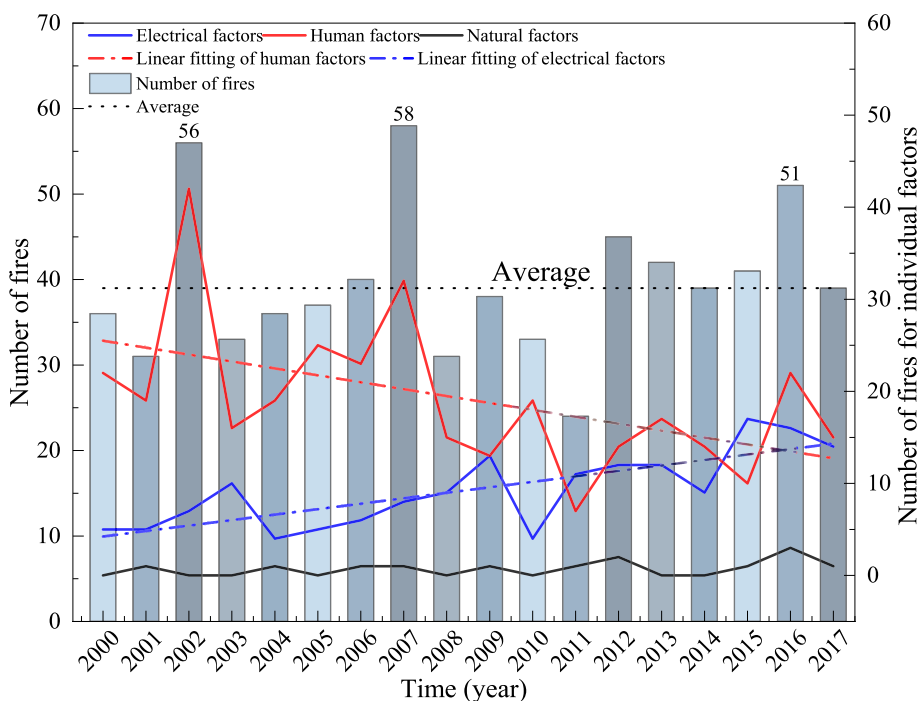
Fig. 2. The number of fire numbers varying years and fire causes regarding historic building fires in 2000–2017.

The relation between the number of fires and their causes between 2000 and 2017 are illustrated in Fig. 2. The causes are divided into fire related to electrical factors (e.g. malfunctions, short-circuits, arc faults, etc.), human factors (e.g. arson, construction works, smoking, playing with fire, careless use of fire such as when cooking, handling fireworks or incense, etc.), and natural factors (thunder, and spontaneous combustion caused by dry and high-temperature conditions). It can be seen that the various types of fires have peaks in certain years. When the number of fires increases abnormally in a certain year, the number of fires will decrease in the following years due to an increase in the people's awareness and prevention practices. This phenomenon agrees with the bathtub curve of human reliability [18]. As referred before, the dry weather can increase the fire risk in historic buildings [17], which agrees with the fact that fires caused by human factors increased sharply. Also, it is found that the number of fires from 2012 to 2017 is higher than the average number of 39. Although the number of fires caused by human factors has decreased to the critical value concerning the fitting linear after 2012 [19], the number of electrical fires still increased, which resulted in a higher number of fires than in previous years. To further detail the causes of past fires in historic buildings, the data associated with each family of factors is discussed in the following.

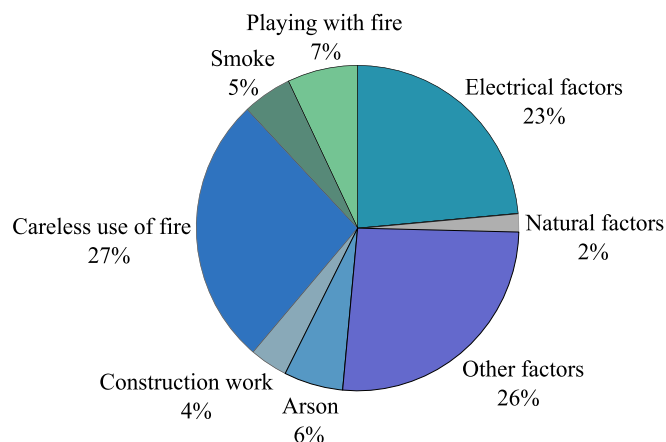
Fig. 3. Disaggregated proportion of fires caused by different factors between 2000 and 2017.

Fig. 3 describes the proportion of fires caused by different reasons from 2000 to 2017. It indicates that fire causes in historic buildings could be divided into electrical factors, human factors, and natural factors. Human factors include arson, construction work, careless use of fire (such as cooking, fireworks, and incense fires), smoke, and playing with fire. Natural factors are summarized as spontaneous combustion (non-manmade fire caused by dry and high-temperature conditions) and thunder. The factors are detailed in the following, respectively.

From the available statistical data, 23 % of historic building fires were caused by electrical factors (Fig. 3). With the enhancement of China’s economic and technological strength, the degree of electrification has increased, and the utilization rate of electrical equipment in various levels of society is seen to be much larger. As such, it can be inferred that fires caused by electrical factors are related to the development of China. Up to now, there are still various non-standard methods for the use and installation of electrical equipment. Some of them have already caused fires in historic buildings, resulting in an overall upward trend of electrical fires. Globally, electrical factors are believed to be the most common cause of historic building fires.

According to Fig. 3, nearly half of historic building fires are caused by human factors. Due to the frequent use of fire in people’s lives,

Sometimes, fires in historic buildings can also occur due to natural factors (Fig. 3). Based on the available data, the number of fires caused by natural factors appears to be relatively stable. Among those, lightning strikes are seen as one of the main causes of damage to older buildings, and is attracting a great deal of attention [21]. This can be explained by the fact that the conditions for the occurrence of fires due to natural factors are coincidental.

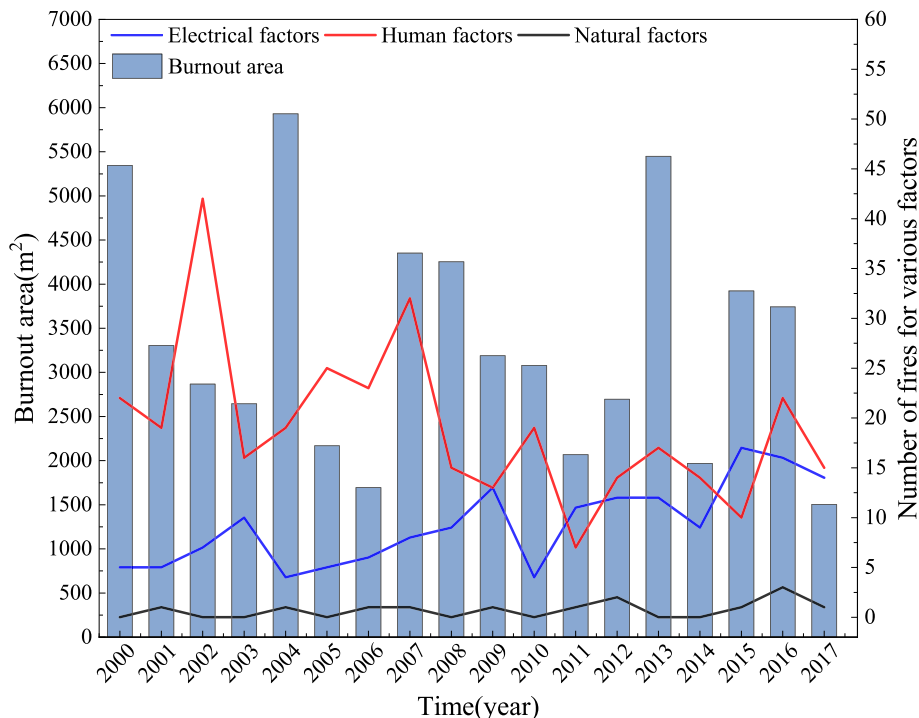
Fig. 5. Burned-out area and trend of fires caused by various factors between 2000 and 2017.

The relation between the direct losses caused by the fires in historic buildings and the number of fires is shown in Fig. 4, while the relation between the burned-out area and the number of fires is shown in Fig. 5. Direct losses include the direct property loss, the fire scene disposal cost, and the personal injury and death fee, which can be directly calculated by the actual cost amount. The cultural and heritage values are not mentioned because they are incalculable. From 2000 to 2017, the maximum direct losses were 11.76 million RMB in 2013 and the maximum burned-out area was 5930 m² in 2004. According to the previous statistics, the number of fires did not show an abnormal increase in those two years. However, when both direct losses and burned-out areas were relatively low (e.g. in 2002), the number of fires caused by human factors increased abnormally. In the correlation analysis between fire causes and damage, no clear relation is found between them. To further explore the bond between these two elements, a quantitative analysis method should be used to calculate the relation between fire damage and different fire causes, which would be useful for managing

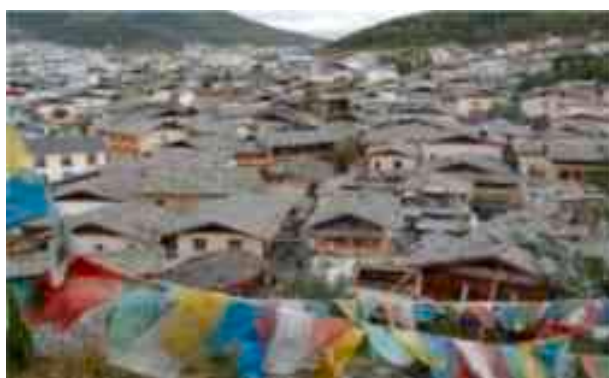
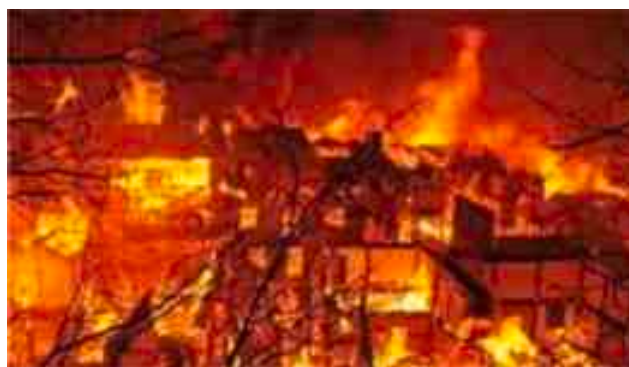
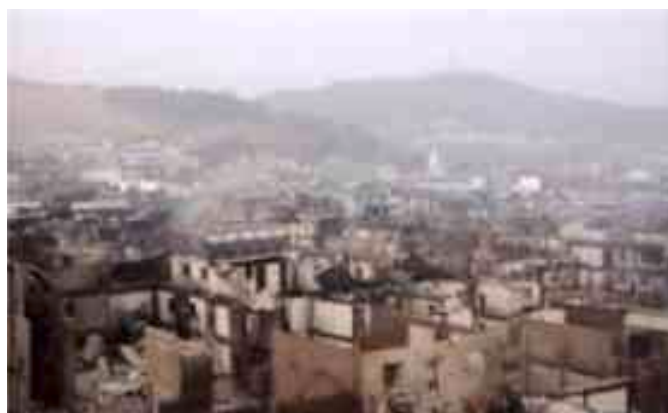
Fig. 7. Fire to Du Ke Zong ancient city. (a) prior to fire (b) in the fire (c) after the fire (http://www.chinadaily.com.cn/dfpd/2014-01/14/content_17233888_4.htm).

Du Ke Zong ancient city has a history of more than 1300 years. Located in Yunnan Province, it is the best-preserved and the largest Tibetan residential community in China. Most of the buildings in the ancient city are in timber. At about 1:10 on January 11, 2014, a fire broke out in the Du Ke Zong ancient city. The total area of housing that was burned by the fire was 599.8 million m^2 (which includes an area of 58.121 m^2 of houses that burnt down and an area of 1859 m^2 of houses demolished during the fire fighting and rescue process). The area of the damaged cultural relics is 2220.45 m^2 , which accounts for 3.7 % of the damaged built area. The ancient city with a history of more than 1300 years was almost destroyed, and the economic loss reached 89.839 million RMB (excluding other direct property losses and public facility losses such as decoration, house facilities, equipment, items, etc.).

The fire accident was the direct result of a person improperly using a five-sided halogen heater in the bedroom. As the person did not turn it off the power before going to bed, the heater accidentally ignited combustible materials and caused a fire. This example belongs to the careless use of fire in the previously highlighted human factors.

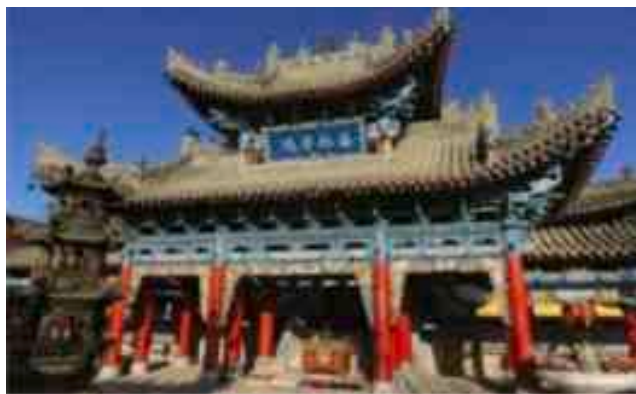
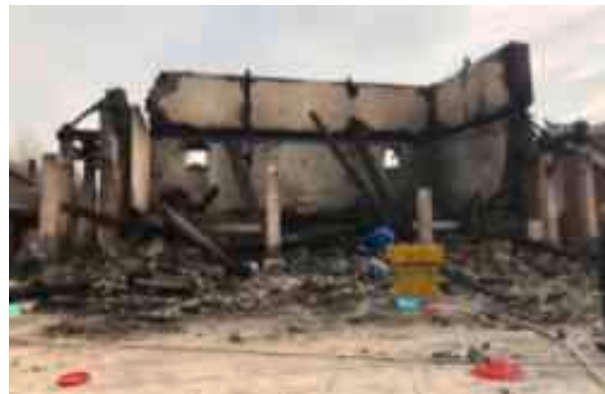
Fig. 8. Fire to Falun Temple (a) prior to fire (b) after the fire (<http://www.chinanews.com/cul/2017/11-01/8365807.shtml>).

On October 30, 2017, a fire broke out at the Dong Pai Hall of Falun Temple, which caused the main (Fig. 7) body of Dong Pai Hall to be burned down, leaving only one wall standing (see Fig. 8). After a preliminary investigation, the cause of the fire was found to be related to the fact that the staff of the Falun Temple put a recently extinguished oil wick in a cardboard box in the east hall before getting off work and leaving. After 9 min, the oil wick reignited and caused a fire. This is also a fire caused by human factors or personnel's poor management of fire

sources. The fire caused the 50 m² Dong Pai Hall to be burned to the ground, but there were no casualties.

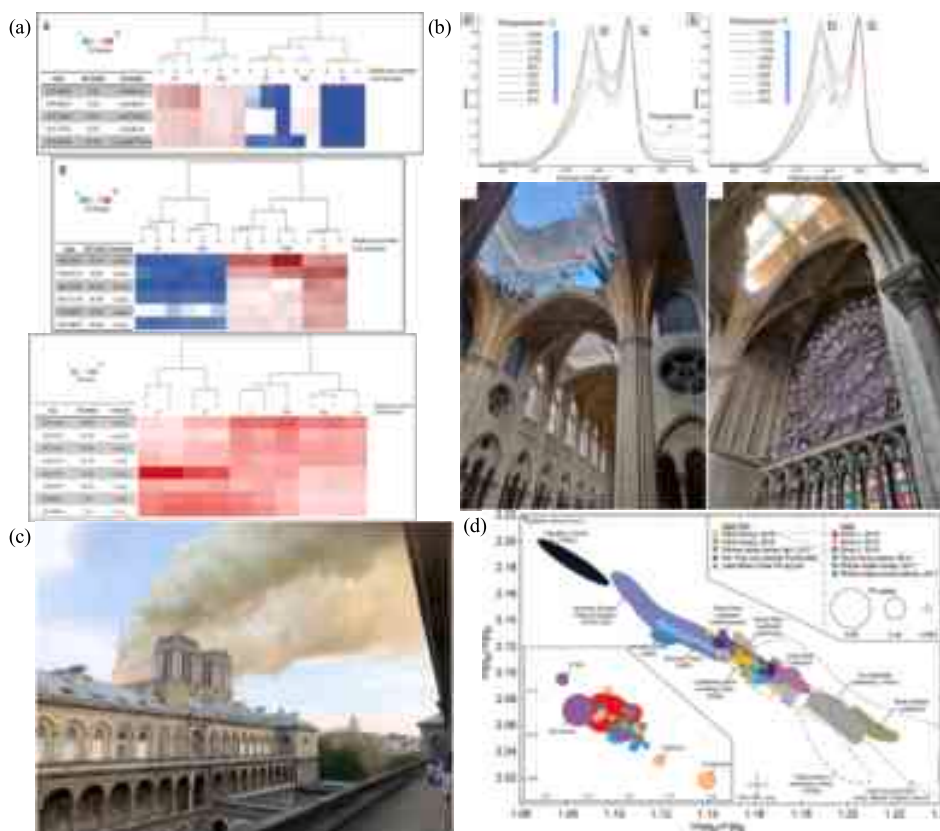
Fig. 13. (a) Dendrogram and selected heatmap for gas samples from five fire tests to compared to the four extinguishing technologies [74]. (b) Raman spectra of experimental charcoals obtained from oak wood with the carbonization temperature. And the openings in the vault show carbonized oak beams and the steel scaffolding deformed by the high temperatures [79]. (c) The fire at Notre Dame as seen from the Hotel-Dieu hospital [80]. (d) Lead isotope plot for all honey [81].
