Mechanical and microstructure evolution of the Tou-Kung joints under weathering conditions

Tou-Kung joints
Mechanical response
Artificial accelerated weathering
Microstructure

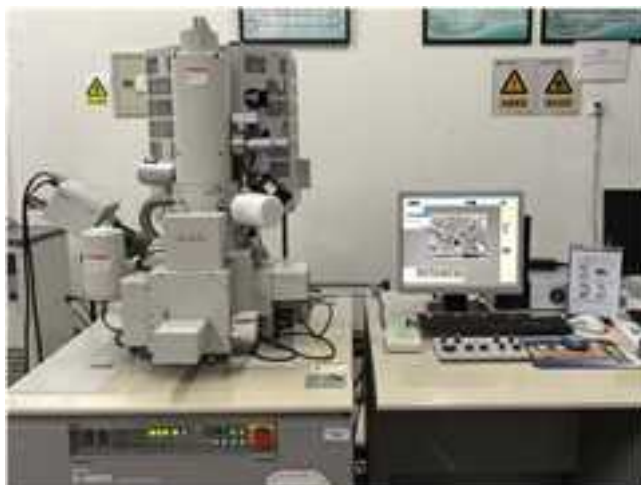
Fig. 6. SEM apparatus.

To elucidate microstructural evolution within cellular frameworks during the weathering of Tou-Kung joints in timber structures, observations were conducted using a Hitachi S-4800 field emission scanning electron microscope (FE-SEM; Hitachi High-Tech, Tokyo, Japan), shown in Fig. 6. The experiments used magnification levels of 600 times and 5000 times. Following weathering completion and static equilibration, specimens were sectioned longitudinally to obtain thin slices (3 mm × 5 mm). These slices were secured with conductive adhesive tape, sputter-coated with gold and imaged under secondary electron (SE) mode using an acceleration voltage of 5 kV.

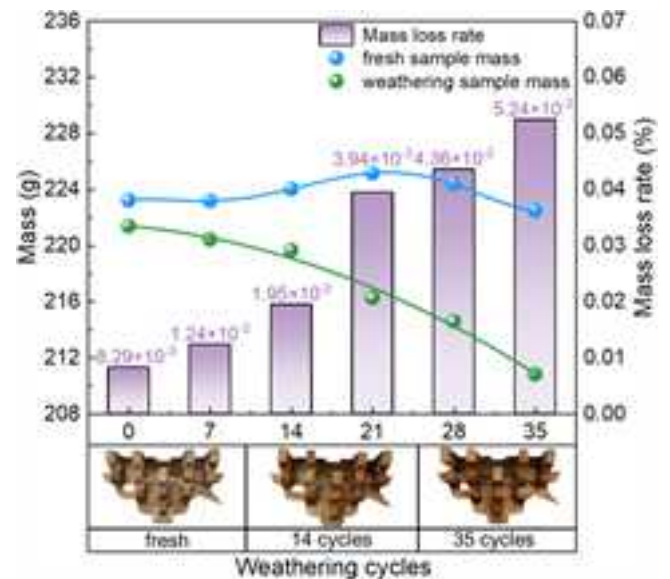
Fig. 7. The mass loss rate of the Tou-Kung joint varies with the weathering cycles.

To assess the impact of artificial accelerated weathering on wooden Tou-Kung joints, mass loss and its rate were quantified across multiple weathering cycles via controlled environmental tests. MLR represents the arithmetic mean of two independently tested specimens per weathering cycle. As shown in Fig. 7, the findings demonstrate a progressive increase in mass loss with the cycling period, particularly after the 21-cycle mark. Concurrently, the mass loss rate exhibits a transient reduction during intermediate stages attributable to water absorption, followed by an escalation caused by component deficiency in later phases, implying that weathering facilitates both transient moisture retention and subsequent structural deterioration.

Wood, as a naturally capillary porous material, stores moisture via free water in cell lumens and bound water in cell walls [38], driving mass shifts linked to hygroscopic traits. During early weathering, Tou-Kung joints' mass loss rose from 0.8 % to 1.5 %, with higher initial mass correlating to greater sensitivity, governed by heat-humidity cycle synergy. Cellulose, a hydrolysis-resistant, high molecular weight linear polymer [48], enhances water permeation by increasing surface area. In contrast, hemicellulose, a soluble polysaccharide mixture with short chains and a branched structure [49], degrades easily under heat,

moisture, and light, significantly reducing hygroscopic capacity and mass stability [20]. Later, mass loss stabilized at 2.6–3.0 % during a slow-change phase, dominated by water spray washing. UV exposure oxidized lignin, depolymerizing molecules into low-molecular-weight (MW) products and lowering lignin content. Concurrent hemicellulose leaching, extractives and inorganic compounds enlarged porosity and pore size [50], inducing surface powderization and detachment. Temperature-humidity cycles also propagated ray-direction cracks in wood, increasing their length and depth as the wood ages, thereby speeding up weathering. Under these combined mechanisms, samples developed characteristic surface exfoliation and progressive mass loss [51], highlighting multi-faceted erosion mechanisms for timber preservation applications.

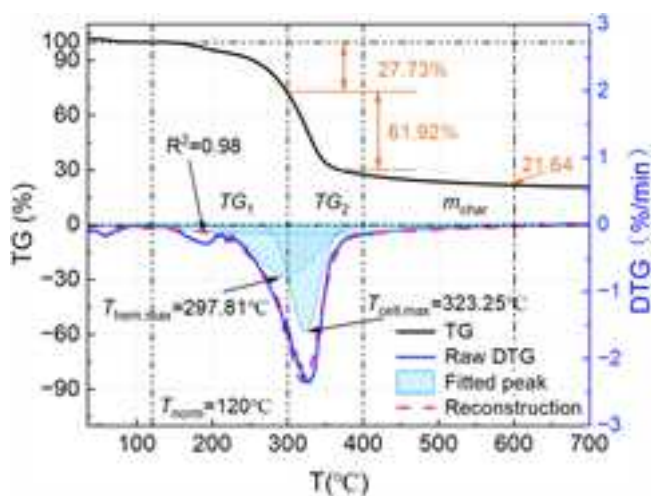
Fig. 9. The stage division of the experimental sample in the combustion process at 10 °C/min.

Normalizing the TG curves at 120°C, where physically adsorbed water evaporates and mass stabilizes, accounted for initial weight loss related to moisture. All reported mass losses and residue yields were calculated relative to this normalization baseline, thereby characterizing the intrinsic thermal degradation behavior of wood. Furthermore, to evaluate how wood weathering affects the mechanical performance of Tou-Kung joints and decipher underlying compositional degradation mechanisms, the evolution of constituents was monitored via TG analysis, as shown in Fig. 9. Results demonstrate that extended weathering reduced the mass loss ratio during hemicellulose degradation TG_1 from 27.73 % to 14.10 %, whereas cellulose degradation TG_2 mass loss fluctuated from 61.92 % to 68.35 %. The DTG peak temperature rose progressively from 329.06°C to 363.57°C, while residual carbon rates varied within 13.15 %–22.77 %. All fitted curves achieved coefficients of determination $R^2 \geq 0.98$, collectively demonstrating that weathering preferentially degrades hemicellulose and modifies the relative thermal stability of wood components.

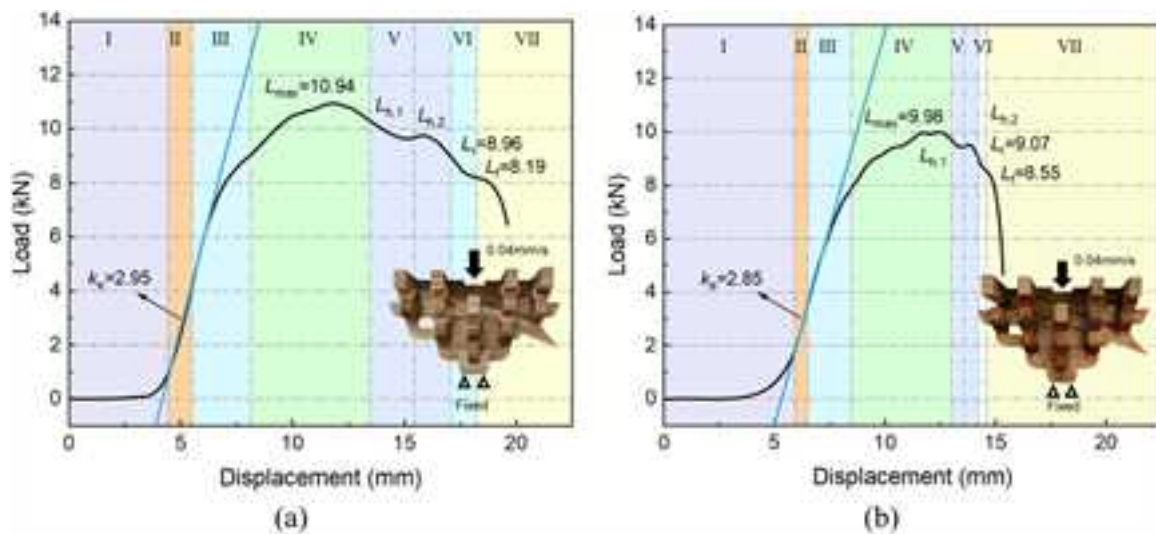
Fig. 10. Vertical pressure-displacement curves of the timber Tou-Kung with different weathering degrees. (a) Fresh sample and (b) weathering 35-cycle sample.

Fig. 10 shows the vertical pressure-displacement curves of the timber

Tou-Kung with different weathering degrees. These curves displayed an initial rise, subsequent decline and final resurgence in load growth rate [45], progressing through eight stages [46]: (I) pre-compaction, (II) elastic, (III) yielding, (IV) load plateau, (V) first strengthening, (VI) second strengthening, (VII) ultimate and (VIII) failure. Critical mechanical parameters are extracted in Table 1. Where k_e denotes the initial stiffness; L_y , L_p , L_r and L_f represent the load-bearing capacities at yield, peak load, ultimate deformation and failure, respectively; while $k_{h,1}$ and $k_{h,2}$ correspond to the stiffnesses during the first and second strengthening stages.

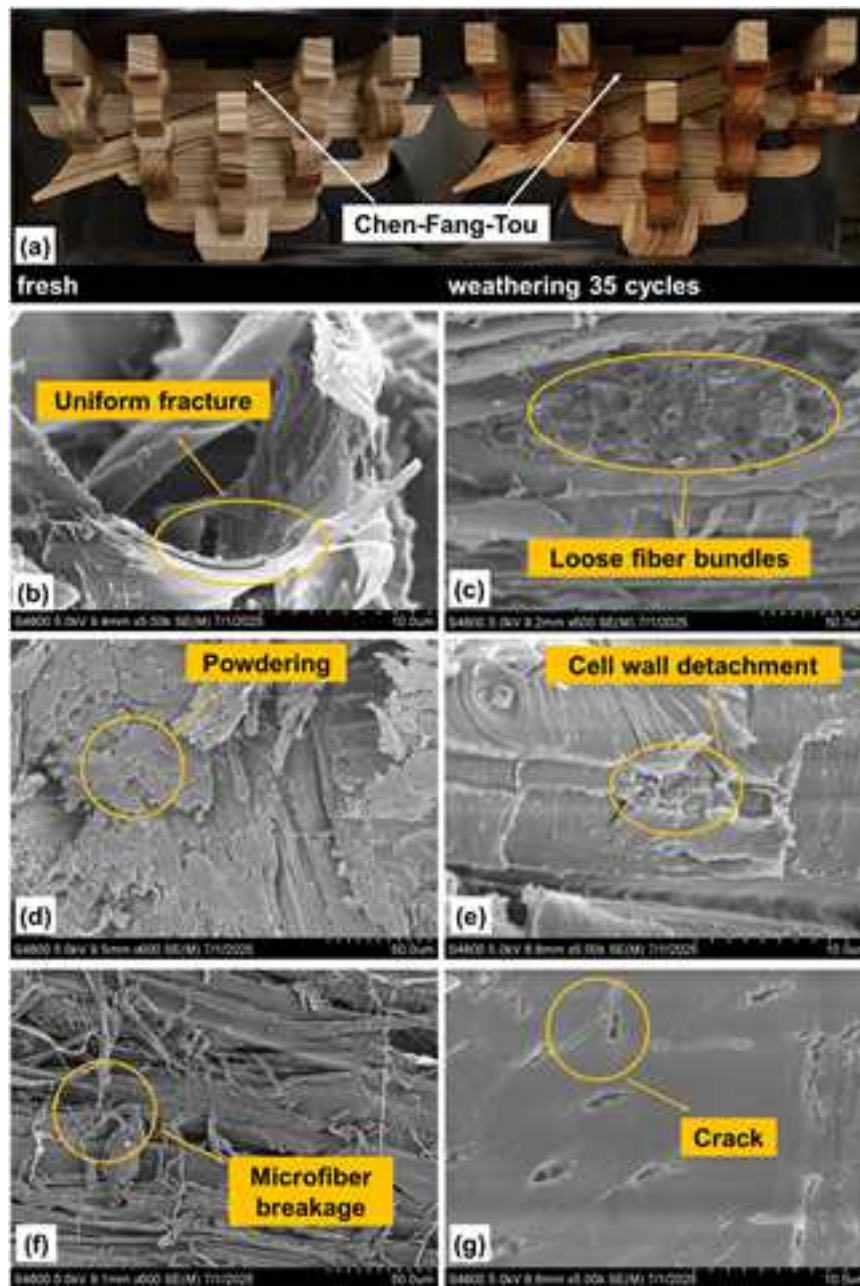
Fig. 11. Scanning electron microscopy (SEM) images showing the microstructural evolution of Tou-Kung joint samples at different weathering cycles. (a) overview of fresh and weathered samples, (b) fresh sample, (c) 7 cycles, (d) 14 cycles, (e) 21 cycles, (f) 28 cycles and (g) 35 cycles.

Wood cell walls consist of the middle lamella, primary wall and secondary wall. Tracheids interconnect via the middle lamella, with cellulose providing skeletal support while hemicellulose and lignin stabilize the internal matrix; lignin additionally preserves middle lamella morphology. Fig. 11(a) illustrates Tou-Kung joints in both fresh

and weathered conditions. The surface morphology of the joints has been significantly damaged due to weathering, accompanied by the presence of decomposition residues. Fig. 11(b) shows fresh samples displaying smooth surfaces, intact tracheid lumens, plump pits, even fractures and microfibrils exhibiting mild surface roughening but no delamination.

Conversely, weathered specimens from Figs. 11(c) to 11(g) exhibited chaotic, degraded surfaces featuring diagonal microcracks and partial cell wall detachment. Microfibril deterioration along tracheid axes disrupted interlayer cohesion, widening pore gaps and loosening fiber bundles. After 21 cycles, microfibrils coarsened and buckled as interfacial bonding weakened. By 28 cycles, cellulose degradation diminished cell wall elasticity, provoking crack propagation through cellulose-rich zones. Concurrent lignin breakdown in the middle lamella reduced intercellular adhesion strength [47]. By 35 cycles, microfibril fragmentation and shedding further compromised structural integrity, inducing surface cracking. These morphological contrasts confirm progressive cellular deterioration and pit expansion due to weathering.

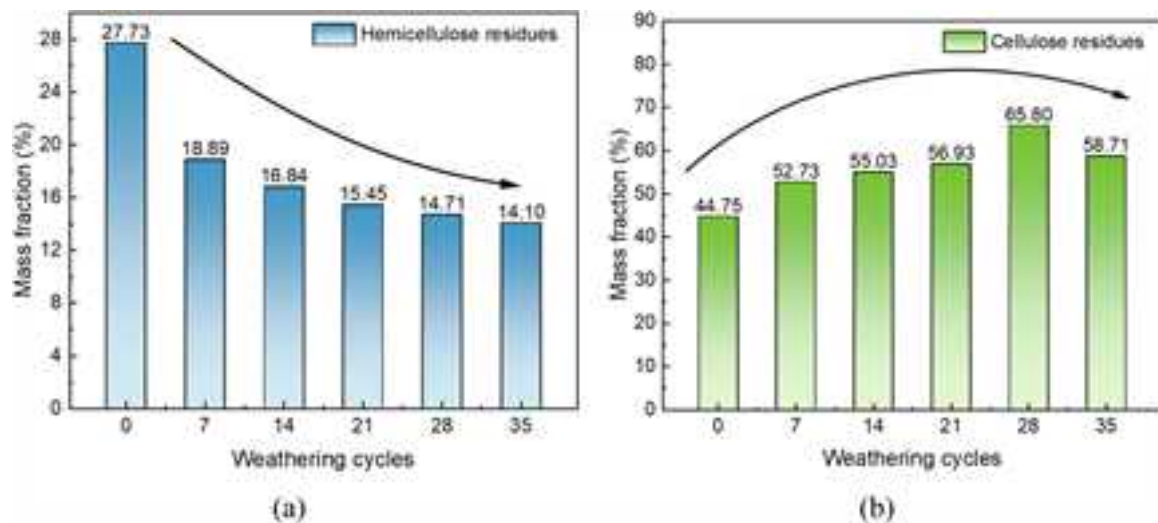
Fig. 12. Mass fractions of hemicellulose and cellulose. (a) Hemicellulose residues and (b) cellulose residues.

The effect of artificial accelerated weathering cycles on the primary chemical constituents of wood was evaluated by calculating the mass fractions of hemicellulose, cellulose, lignin and char via secondary processing of TG data, as shown in Fig. 12. Results indicate that increasing the weathering cycle from 0 to 35 cycles led to a significant decrease in hemicellulose fraction, relatively stable cellulose fraction, minor fluctuations in lignin fraction and a marked increase in char fraction. This suggests accelerated weathering promotes hemicellulose degradation and enhanced char formation. Cyclic hygrothermal exposure degrades hemicellulose and cellulose. Hemicellulose is a heteropolysaccharide with high branching, low polymerization, amorphous structure and short-chain morphology, displaying the poorest thermal stability due to its susceptibility to hydrolysis [56]. Initial mass loss below 250°C was attributed to decomposition of hemicellulose-derived

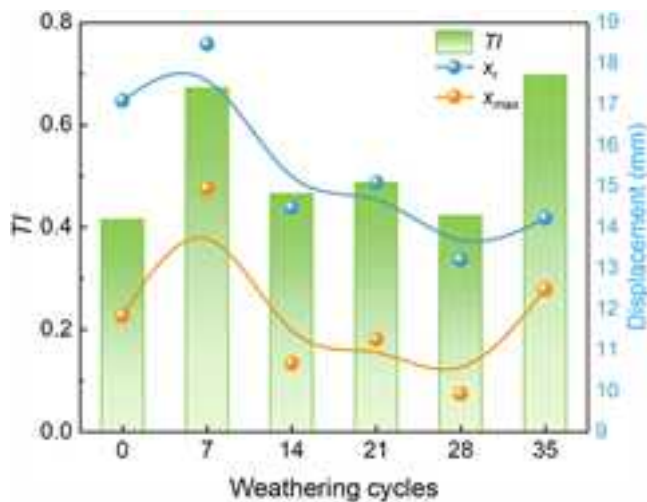
Fig. 13. The Tl evolved with weathering cycles.

As shown in Fig. 13, the TI evolved with weathering time: 0.41 at 0 cycles, 0.67 at 7 cycles, 0.46 at 14 cycles, 0.49 at 21 cycles, 0.42 at 28 cycles and 0.70 at 35 cycles. It should be noted that while the TI increased at 7 cycles due to moisture-induced plasticization and hygroscopic swelling. And increased at 35 cycles due to loss of structural integrity, rather than intrinsic toughening, a phenomenon also observed in aged polymers and composite biomaterials [62]. For Tou-Kung joints weathered for 35 cycles, structural deficiencies extended the pre-compression phase [63], yielding a larger maximum-load displacement but smaller overall compressive displacement. When excluding structural damage, the toughness index of Tou-Kung joints declined as weathering duration increased. Decreasing TI values suggest that the load-bearing displacement converges toward the limit displacement, diminishing load capacity and elevating failure risk. Fig. 13 further reveals a reduction in ultimate displacement at ultimate stress, consistent with the inference that weathering exacerbates mechanical failure at

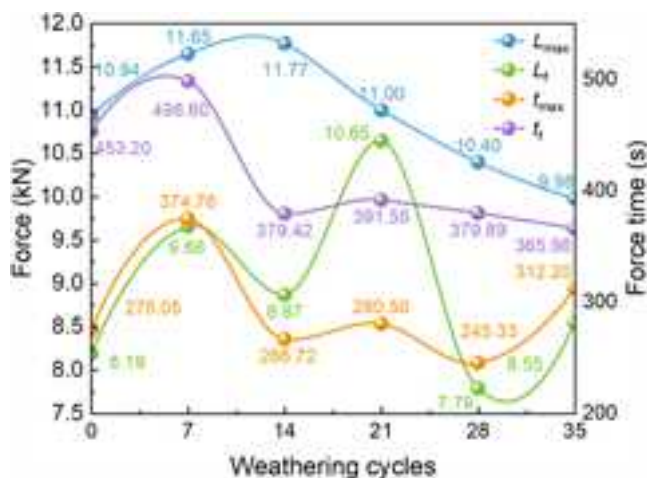
Fig. 14. The maximum bearing capacity, failure bearing capacity and time of wooden Tou-Kung joints change with the degree of weathering.

As shown in Fig. 14, the temporal effects of weathering on the mechanical behavior of traditional Tou-Kung joints were investigated through experimental quantification of dynamic load-bearing capacity. During the initial 14-cycle weathering stage, mechanical performance improved significantly, with maximum load capacity reaching 11.77 kN, representing an 8.4 % increase over fresh specimens, driven by moisture-induced material expansion and enhanced compressive resistance. Progressive deterioration subsequently occurred, as evidenced by the reduction in peak load capacity from 11.77 kN to 10.40 kN after 28 cycles, and 9.98 kN after 35 cycles. Nonlinear temporal patterns emerged as time-to-maximum-force decreased to 266.72 s during the 14 cycles before increasing to 245.33 s later. Microstructural analysis demonstrated that early microcrack propagation optimized stress distribution efficiency, while prolonged weathering degraded structural integrity through cellulose chain fracture and hemicellulose dissolution [64]. Observed surface fragmentation and roughening of microfibrils corresponded with failure mode fluctuations arising from local stress concentrations induced by percolating fluids. These findings collectively establish a comprehensive framework for interpreting time-dependent performance degradation in historical

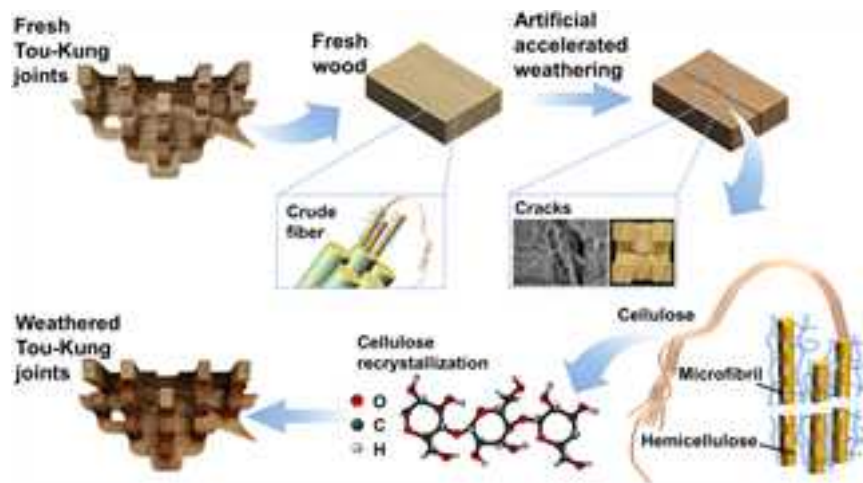
Fig. 15. Schematic diagram illustrating the degradation mechanism of Tou-Kung joints mechanical response at weathering conditions.

This study systematically examines the evolution of Tou-Kung joint properties under weathering conditions, focusing on both mechanical performance and microstructural changes, as shown in Fig. 15. Results indicate that Tou-Kung joint undergoes distinct, multi-stage physical and chemical transformations when exposed to weathering, with each stage influencing the mechanical strength and microstructural integrity [65]. As the weathering cycle increases, the hemicellulose mass fraction drops significantly from 27.73 % to 14.10 % and the peak temperature for cellulose thermal decomposition rises from 329.06 °C to 363.57 °C, indicating molecular chain rearrangement and increased crystallinity [66]. After 21 cycles of weathering, the microfibril surface becomes rough and buckled. By 35 cycles, severe dissociation and fracture along the vessel axis occur, directly related to increased brittleness caused by cellulose recrystallization [67]. The macroscopic mechanical response shows that in the initial weathering stage, hygroscopic expansion briefly raises the peak load by 6.5 %. However, as weathering continues, the peak load decreases at 21 cycles. In the later stage, the peak load drops by 8.8 % compared to the initial value.
